Manhole Inspection Summary

Manhole # S45II_031MH

Insp Date: **4/25/08 12:47 PM**

Location Address: **Wolf St**

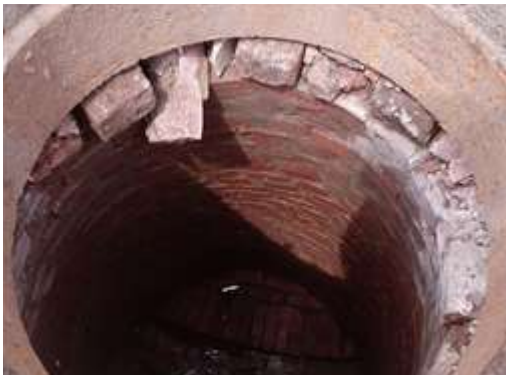
Defect 1

Condition: ☐ Sound ☐ Cracked ☐ Root Intrusion ☒ **Loose Brick** ☐ Deteriorated

Infiltration: ☐ None ☐ Joint ☐ Cracks ☒ **Mortar** ☐ Roots ☐ Wall

Loose Bricks

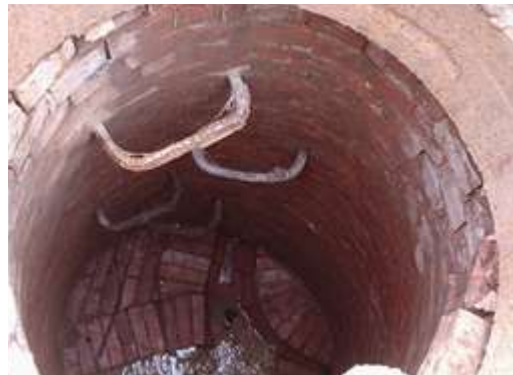
Defect 2

Deterioration

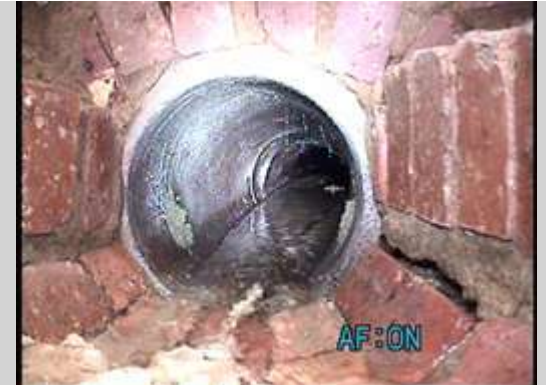
12 O'Clock Outflow

8 in. Circular Gravity Sewer
Pipe Out @ 12 O'Clock

Pipe Height: **8.4** (in.) Rod and Bar (Angled)
Pipe Material: **Clay** ☐ Pipe Lined
Invert Depth: **8.60** (ft.) Flow Characteristics: **Fast**
Deposits: ☒ None ☐ Mud ☐ Sludge ☐ Debris ☐ Grease
Silt Depth: (in.) Deposits Extent:
Infiltration: **None** Pipe Seal Cond: **Sound**

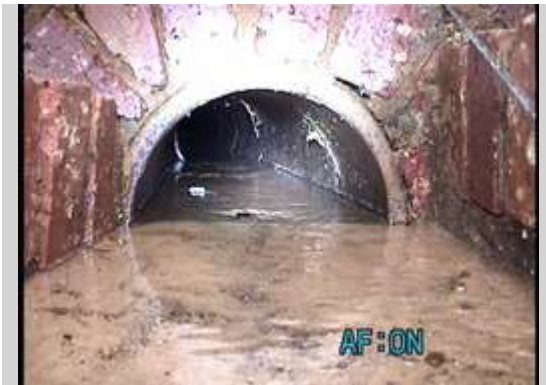
5 O'Clock Inflow

8 in. Circular Gravity Sewer
Pipe In @ 5 O'Clock

Pipe Height: **8.4** (in.) Rod and Bar (Angled)
Pipe Material: **Clay** ☐ Pipe Lined
Invert Depth: **8.55** (ft.) Flow Characteristics: **Fast**
Deposits: ☒ None ☐ Mud ☐ Sludge ☐ Debris ☐ Grease
Silt Depth: (in.) Deposits Extent:
Infiltration: **None** Pipe Seal Cond: **Sound**

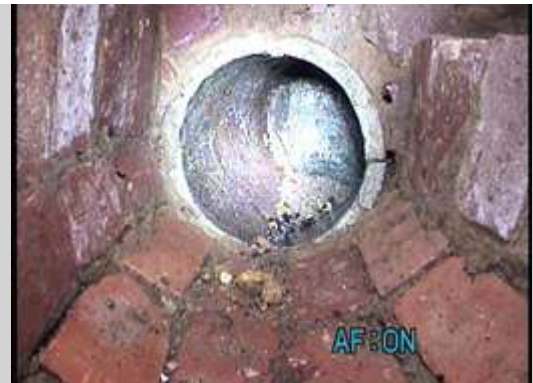
9 O'Clock Inflow

6 in. Circular Gravity Sewer

Pipe In @ 9 O'Clock

Pipe Height: **6** (in.) Rod and Bar (Angled)

Invert Depth: **8.15** (ft.) Flow Characteristics: **None**

Infiltration: **None**

Pipe Seal Cond: **Sound**

Connects To: **House connection / Service line**
